Manhole Inspection Summary

Manhole # S43KK_017MH

Insp Date: **8/13/08 9:29 AM**

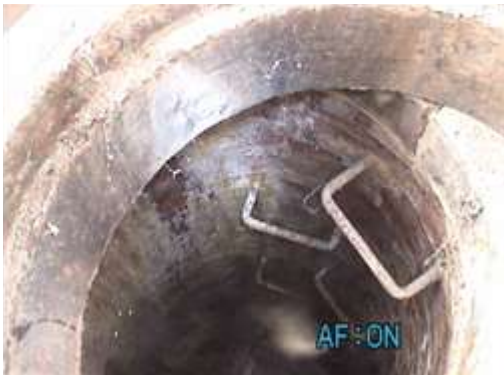
Defect 1

Frame Offset: **6** (in.) Condition: ☐ Sound ☐ Cracked ☒ **Leaks**

Frame leaks

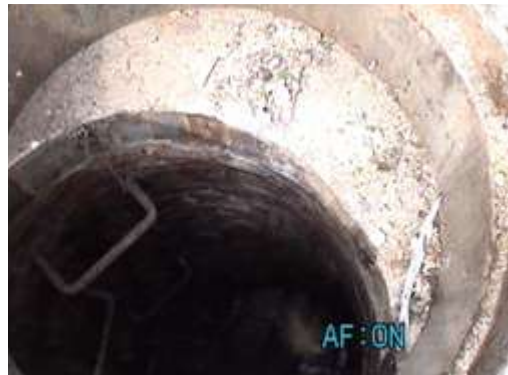
Defect 2

Infiltration: ☐ None ☒ **Joint** ☐ Cracks ☐ Mortar ☐ Roots ☐ Wall

Infiltration: ☐ None ☐ Joint ☐ Cracks ☐ Mortar ☐ Roots ☒ **Wall**

Infiltration

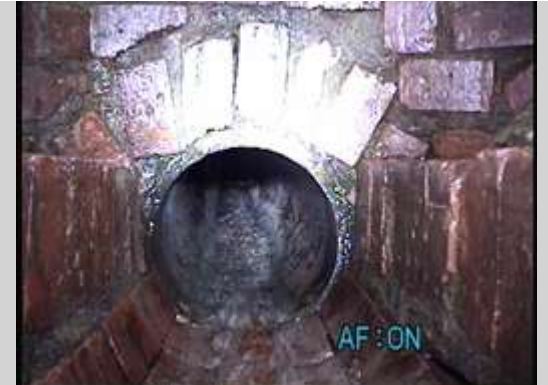
12 O'Clock Outflow

8 in. Circular Gravity Sewer
Pipe Out @ 12 O'Clock

Pipe Height: **8.4** (in.) Rod and Bar (Angled)
Pipe Material: **Clay** ☐ Pipe Lined
Invert Depth: **12.25** (ft.) Flow Characteristics: **Slow**
Deposits: ☒ None ☐ Mud ☐ Sludge ☐ Debris ☐ Grease
Silt Depth: (in.) Deposits Extent:
Infiltration: **None** Pipe Seal Cond: **Sound**

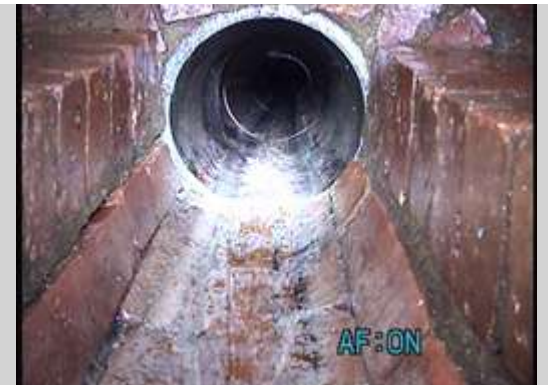
6 O'Clock Inflow

8 in. Circular Gravity Sewer
Pipe In @ 6 O'Clock

Pipe Height: **8.4** (in.) Rod and Bar (Angled)
Pipe Material: **Clay** ☐ Pipe Lined
Invert Depth: **11.70** (ft.) Flow Characteristics: **Slow**
Deposits: ☒ None ☐ Mud ☐ Sludge ☐ Debris ☐ Grease
Silt Depth: (in.) Deposits Extent:
Infiltration: **None** Pipe Seal Cond: **Sound**
